Navajo Abandoned Uranium Mine Site Screen Report

Section 13 AUM Site

Navajo AUM Eastern Region

May 2009

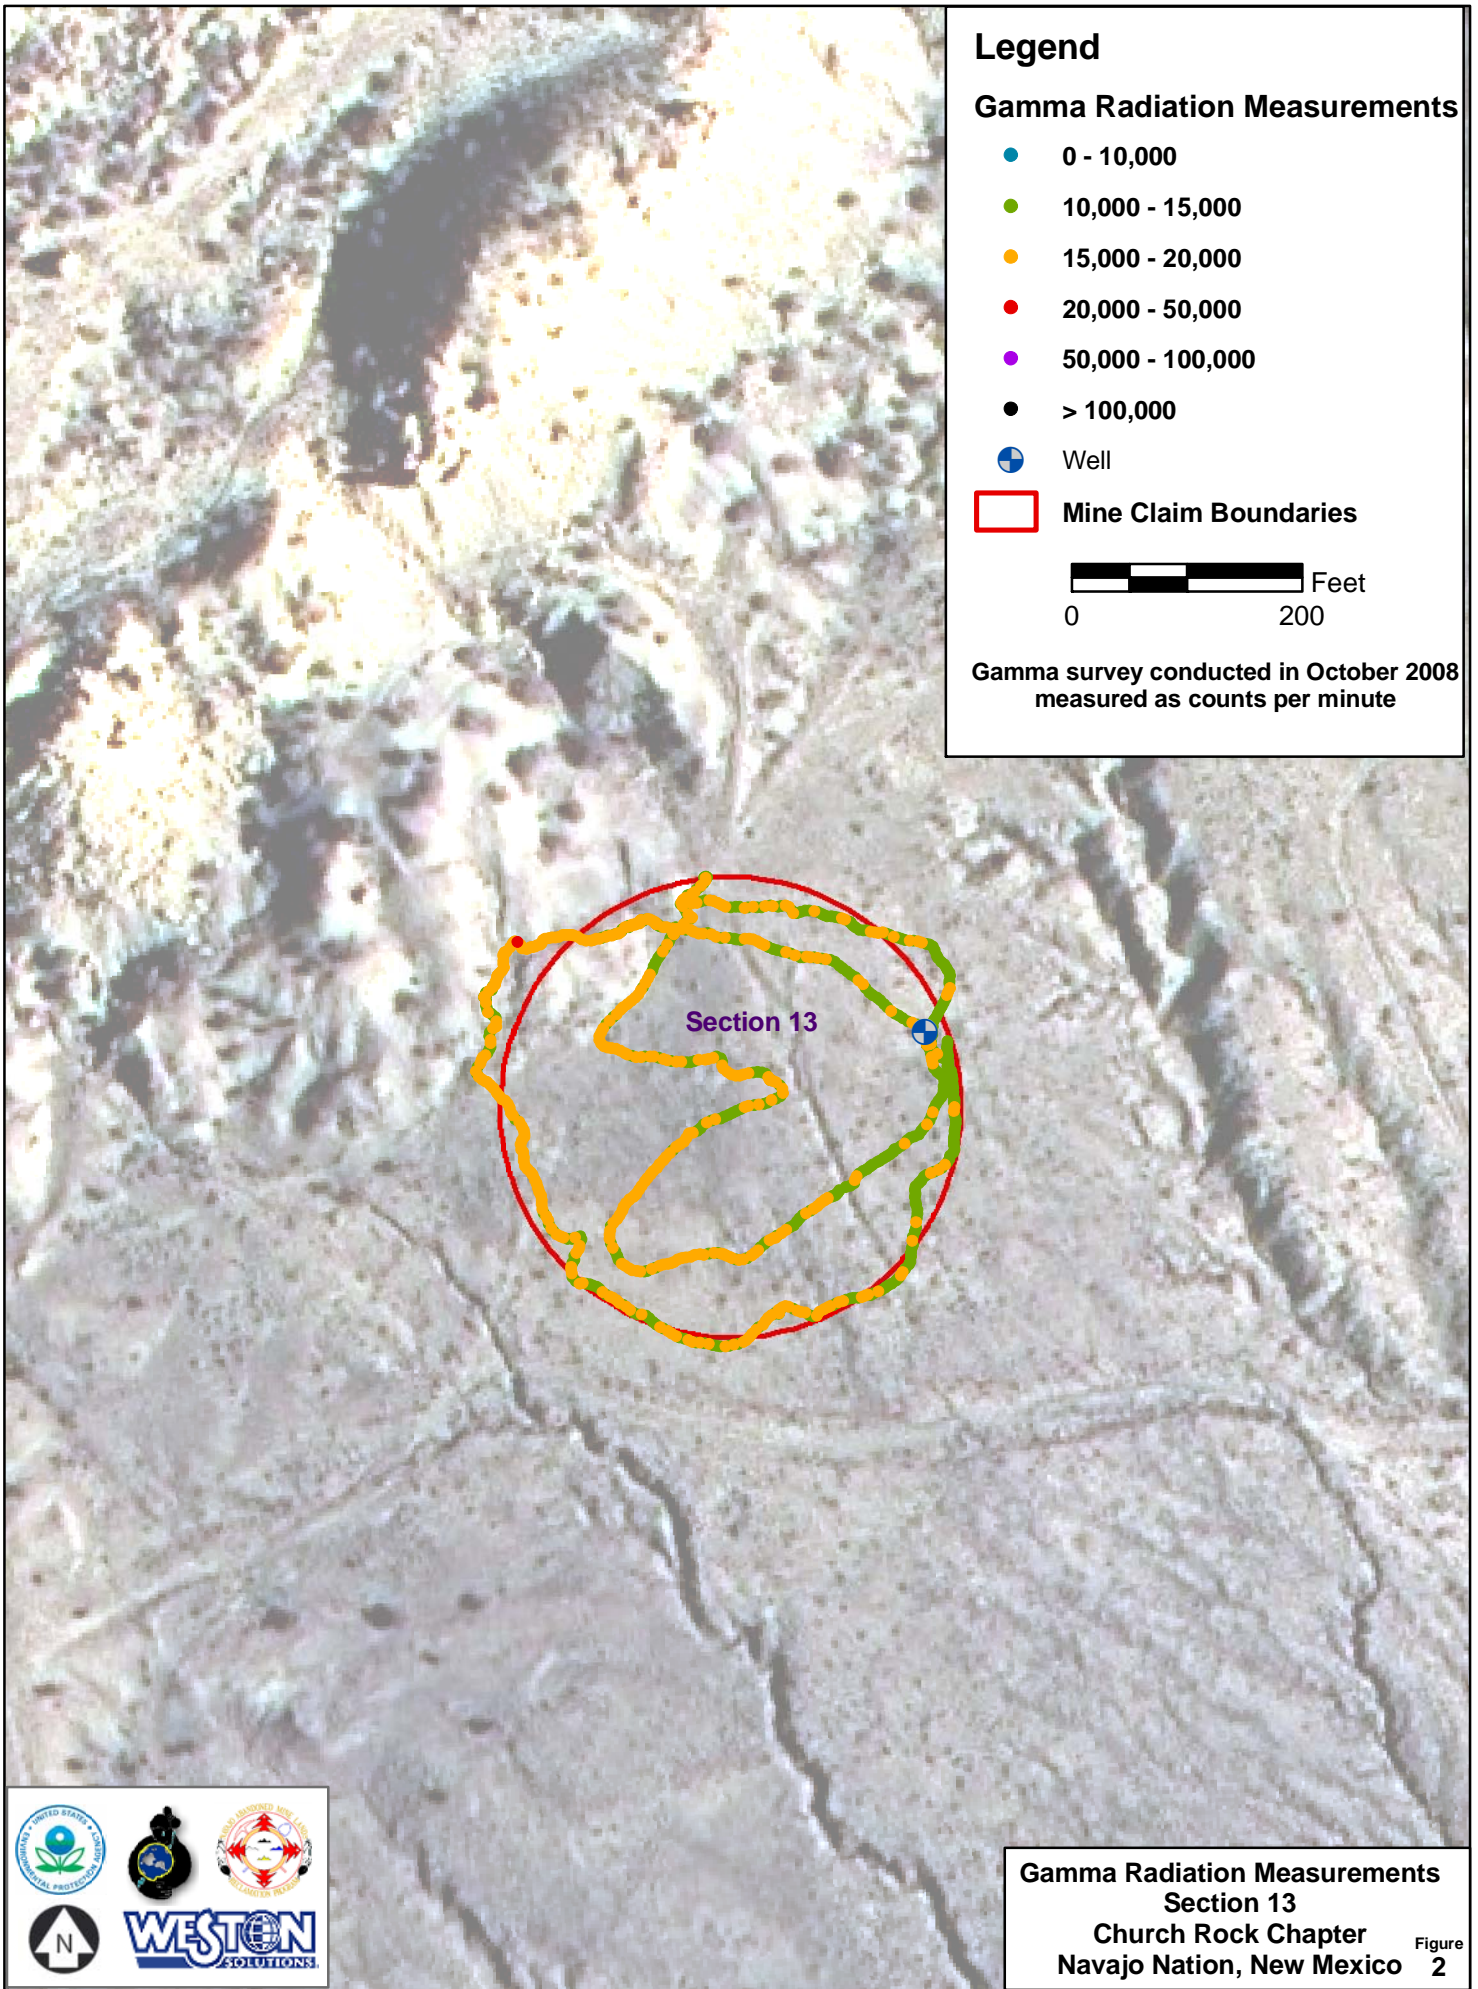
Figure
1

A total of 953 gamma radiation measurements were collected from mine sites, ranging from 11,796 cpm to 20,667 cpm. The measurements are represented in Figures 1 and 2.
